Dead Dog Basin Footbridge

Inspection and Assessment Report

Document Ref: 10049461-ARC-SBR-01-RP-SE-0001

DECEMBER 2021

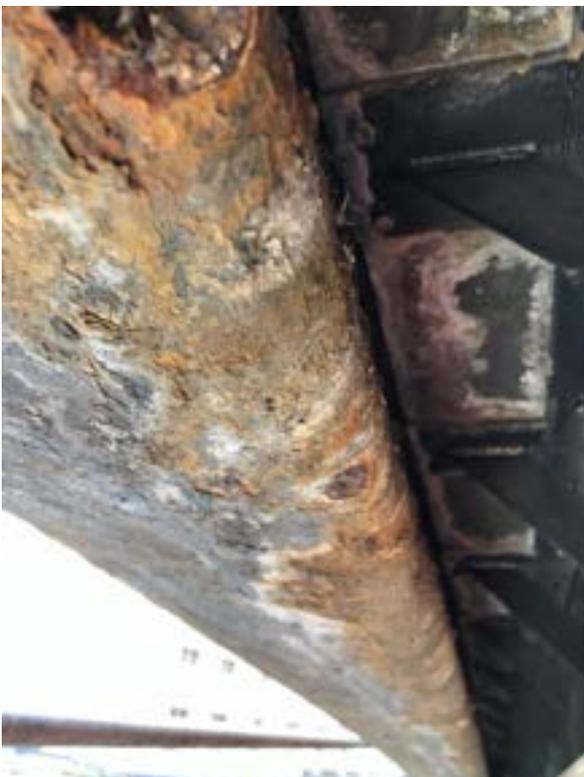
- Delamination caused by general surface corrosion is noted along the entire length of both the canal side and basin side edge I girders. (See Photos 1 – 3).
- Full thickness section loss in the lower flange to the canal side edge I girder measured approximately 65mm in width at the midspan. (See Photos 4 – 5).
- Full thickness section loss in the lower flange to the canal side edge I girder toward the west abutment measured approximately 70mm in width and 30mm into the flange. (See photos 6 – 7)
- Pitting to the web on the basin side edge I girder toward the west abutment. (See photo 12)

Photo 2: Delamination of northside edge I girder

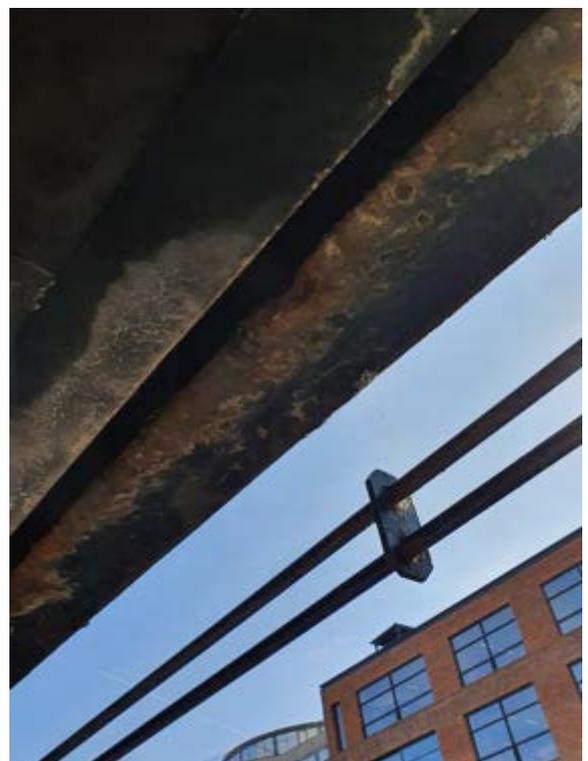
Photo 3: Delamination of southside edge I girder

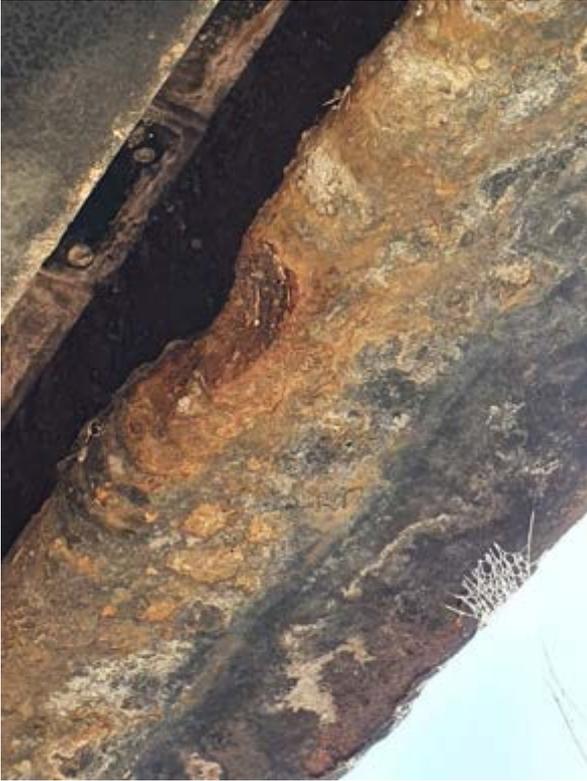
Photo 4: Full thickness section loss of bottom flange of canal side edge beam

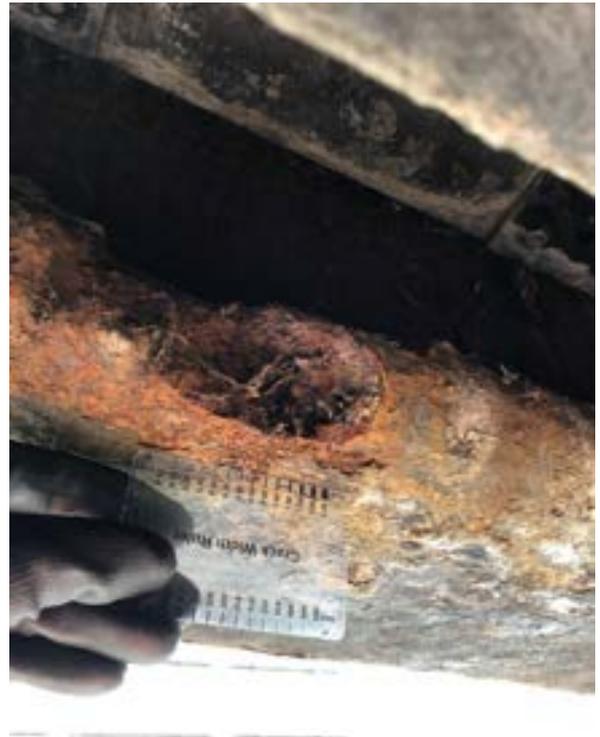
Photo 5: Full thickness section loss of bottom flange of canal side edge beam

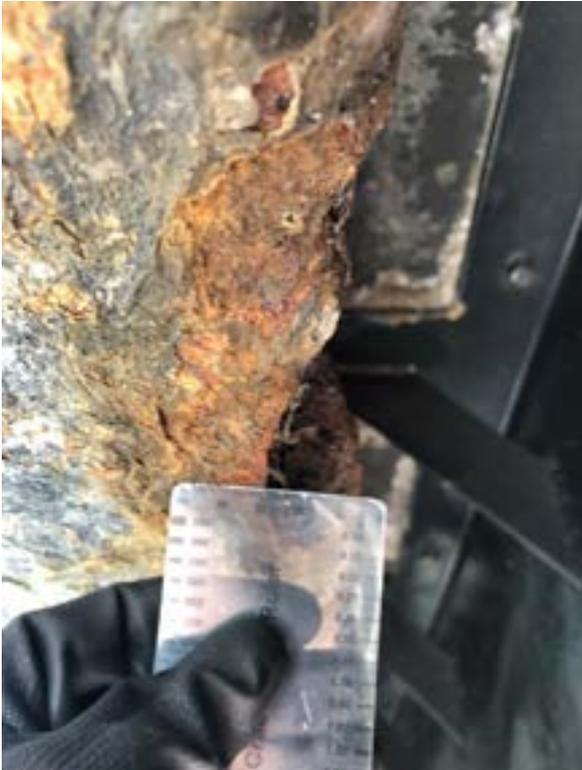
Photo 6: Full thickness section loss of bottom flange of canal side edge beam towards west abutment

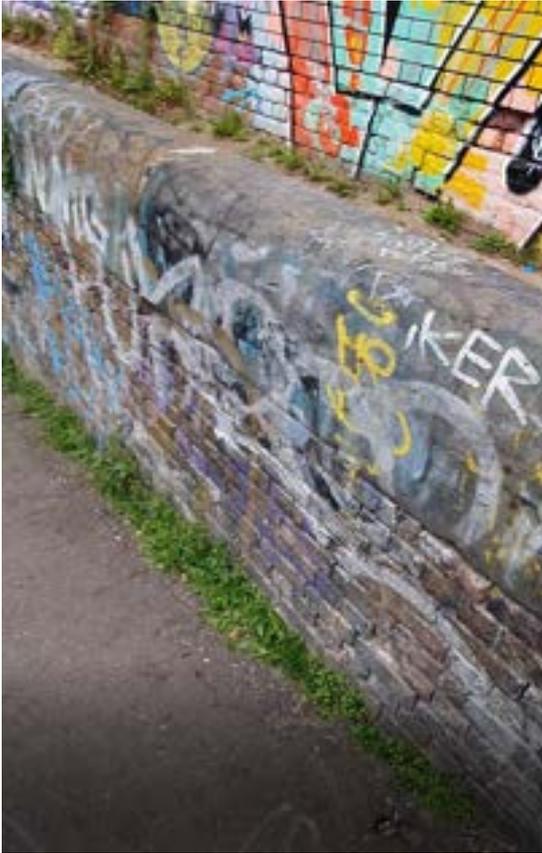
Photo 16: Vegetation growth on the east ramp

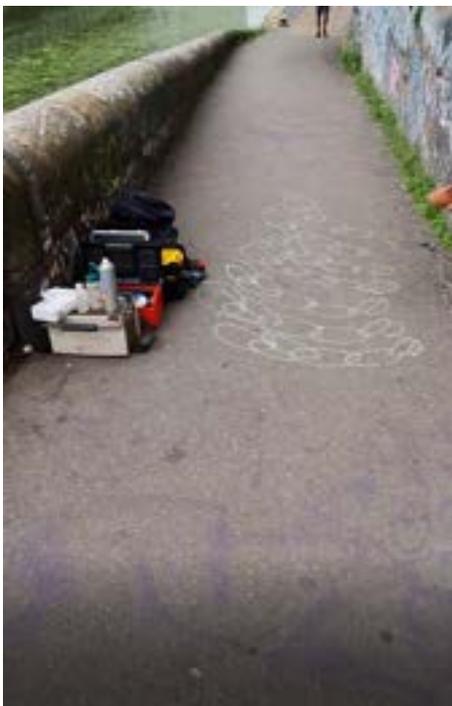
Photo 18: Loss of tarmac surfacing on the east ramp

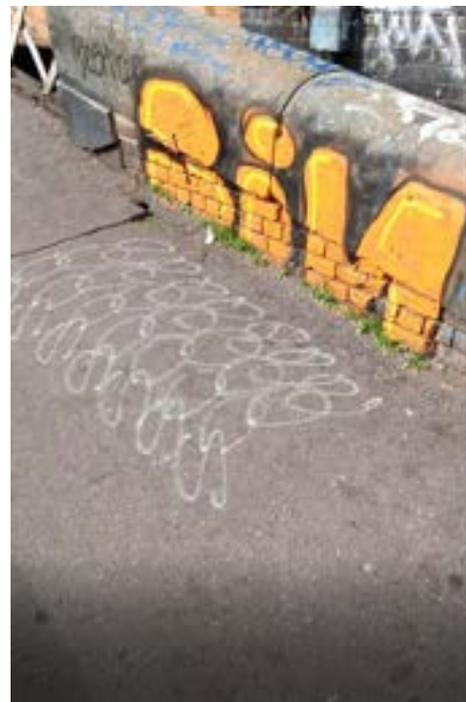
Photo 19: Graffiti on west ramp surfacing

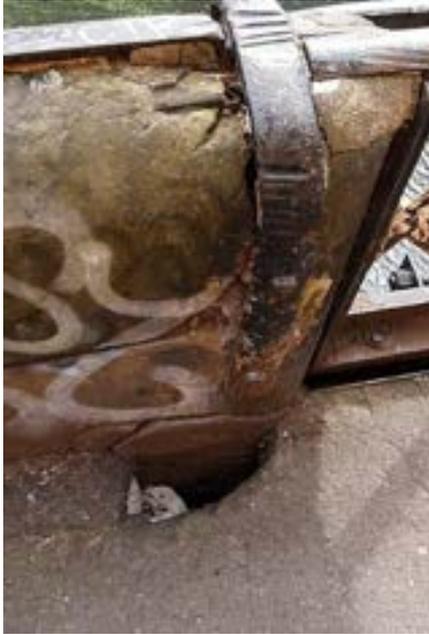
Photo 20: Graffiti on east ramp surfacing

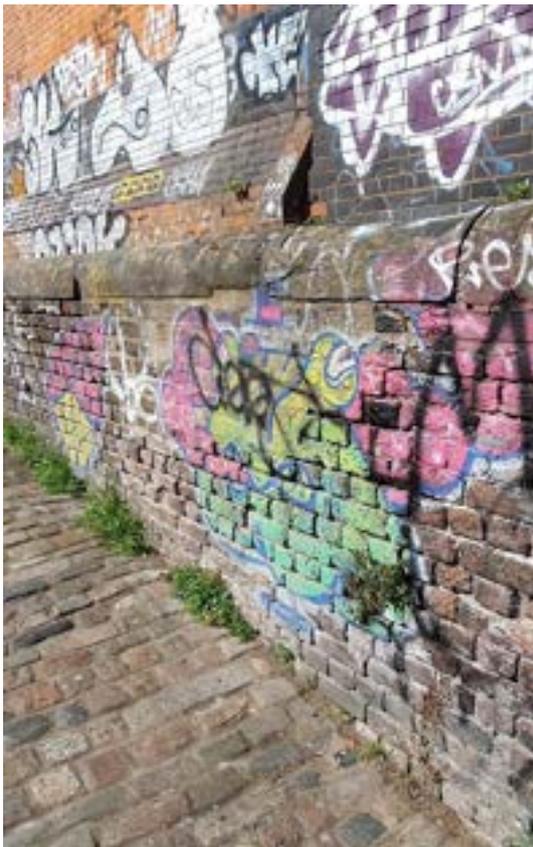
Photo 22: Hole on east ramp basin side

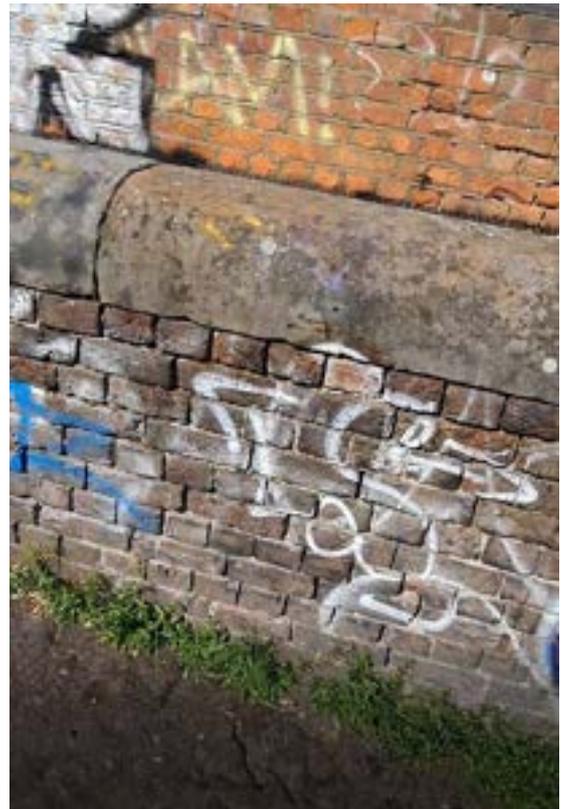
Photo 23: Graffiti to the boundary wall on east ramp

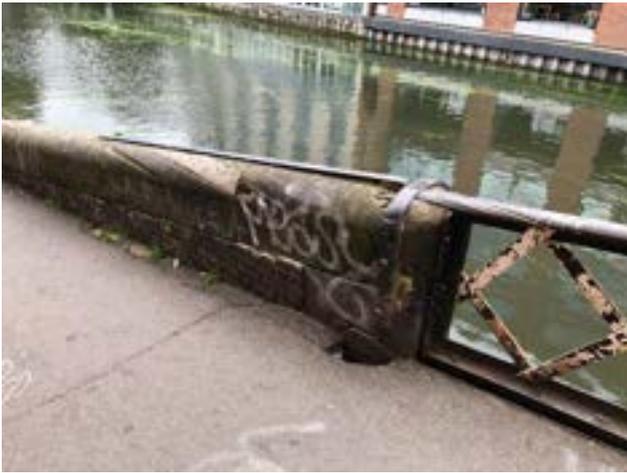
Photo 24: Loss of mortar to the boundary wall on the east ramp

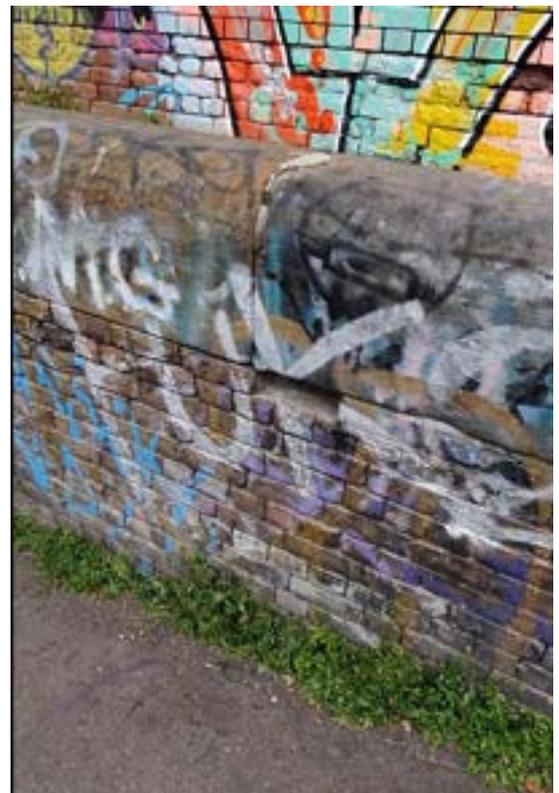
Photo 27: Graffiti to the boundary wall on the west ramp.

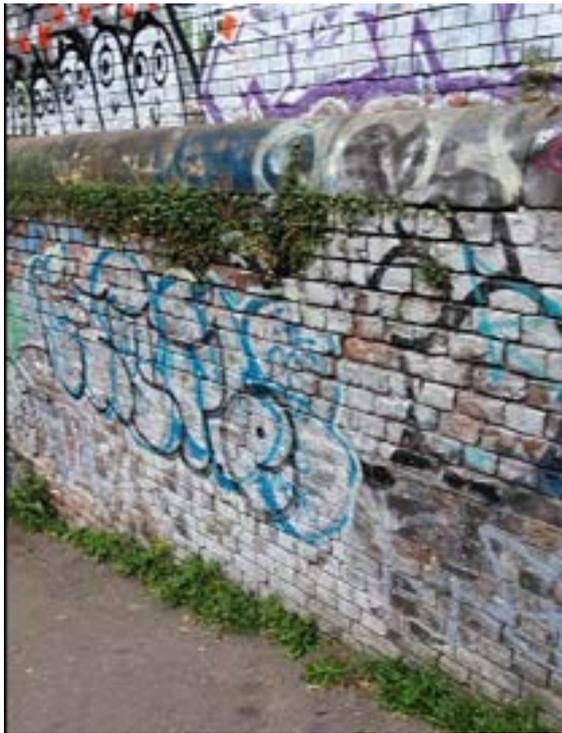
Photo 28: Loss of mortar and brick to the boundary wall.

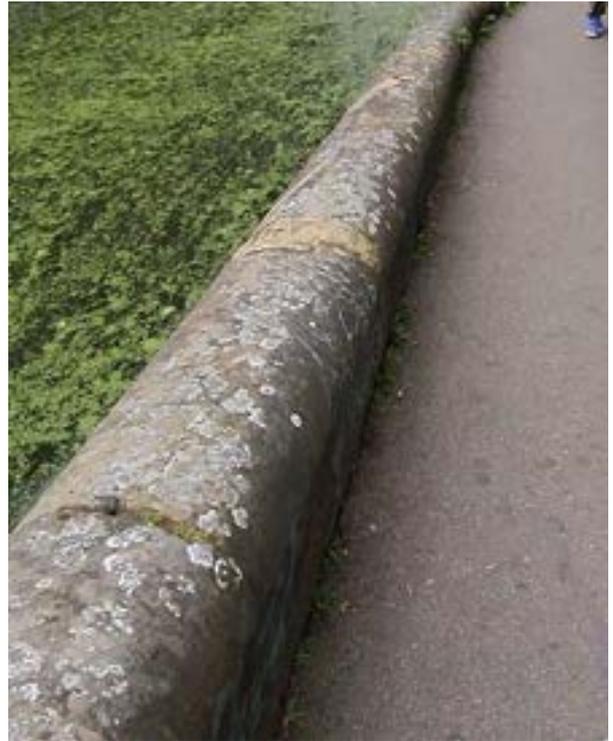
Photo 29: Vegetation on the boundary wall on the west ramp.

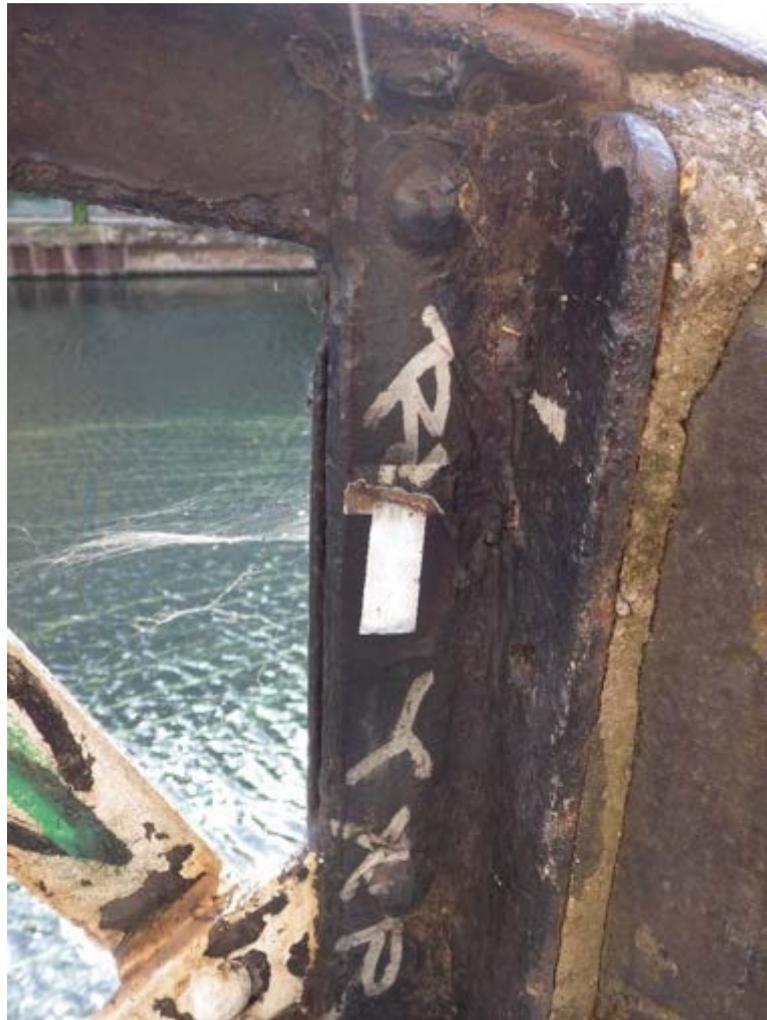
Figure 8: Overview of Area 4.

RM, Figure 24, showed the vertical side steelwork to be a wrought iron material. The micrograph shows typical elongated large dark coloured slag inclusions in a ferrite matrix.

Hardness measurement of Area 4 showed it to be ~119Hv, typical of this type of material.

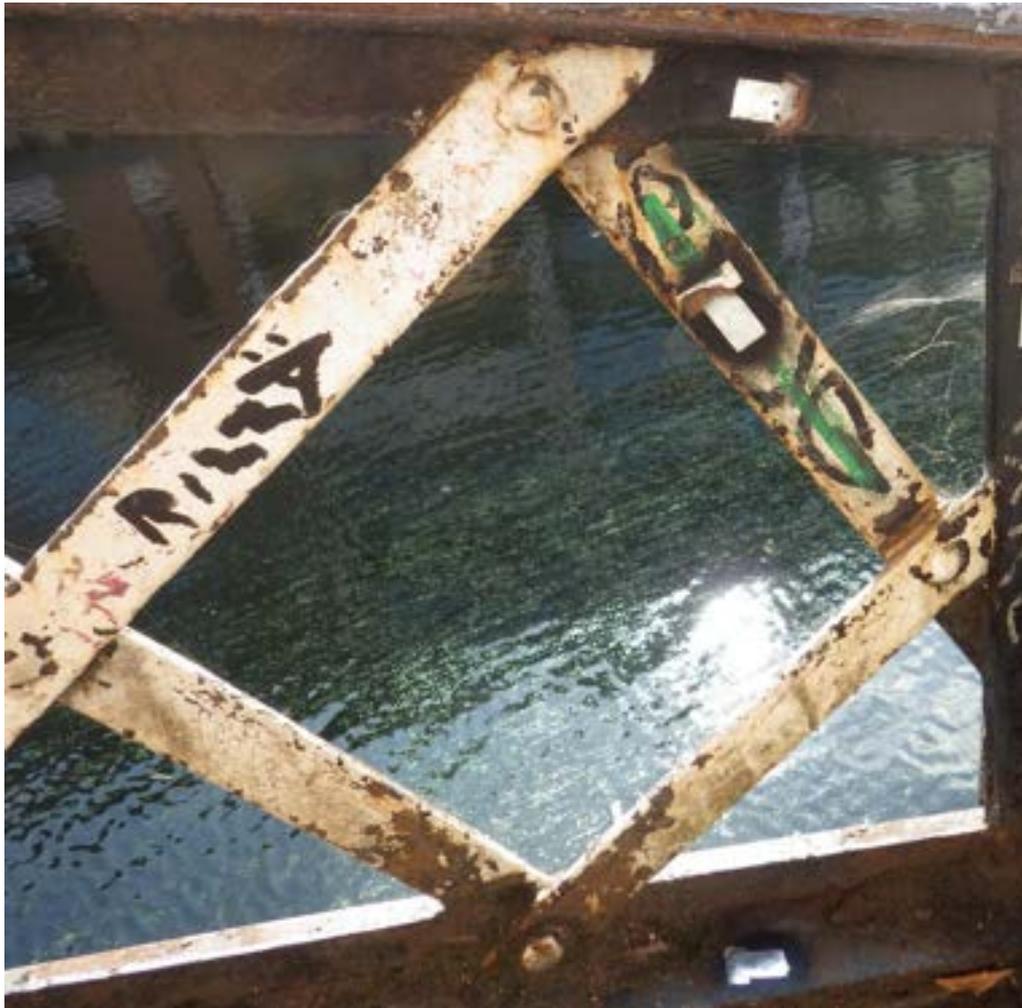
Figure 9: Overview of Area 5.

RM, Figure 28, showed the lattice work to be a wrought iron material. The micrograph shows typical elongated large dark coloured slag inclusions in a ferrite matrix.

Hardness measurement of Area 5 showed it to be ~121Hv, typical of this type of material.

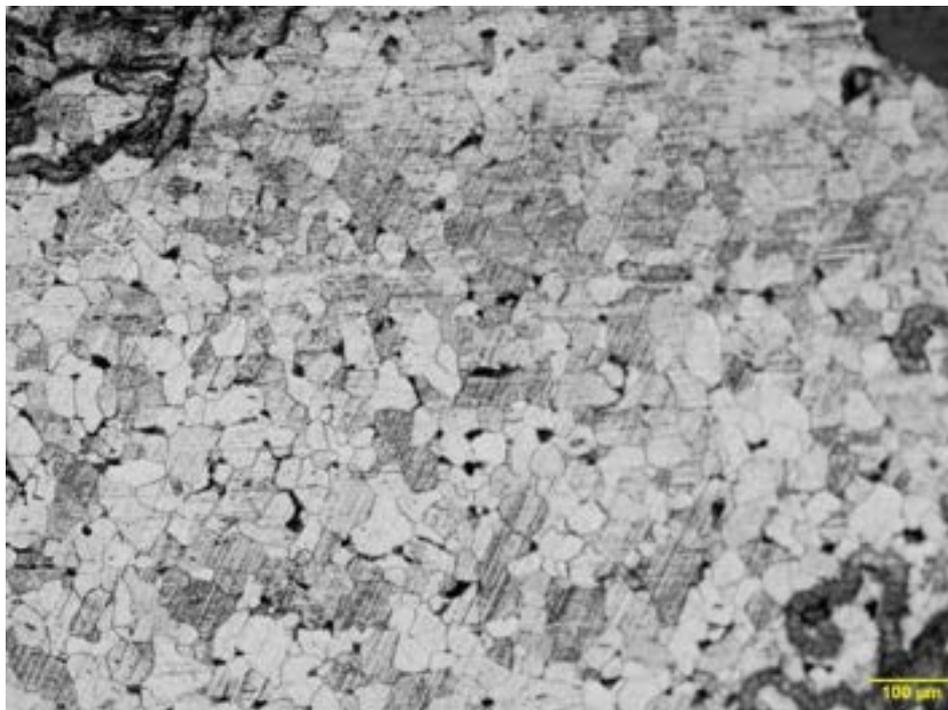
Figure 20: Etched micrograph of sample removed from structure, showing typical carbon steel microstructure.

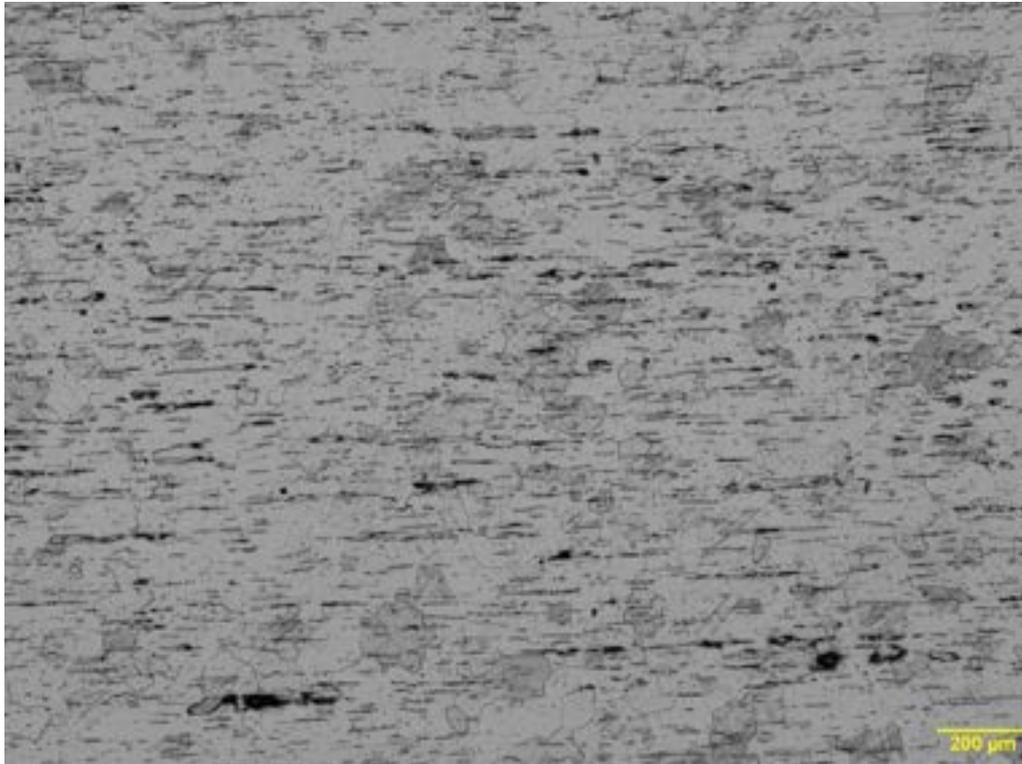
Figure 28: Etched RM micrograph showing typical wrought iron microstructure.
